marine lubricants information bulletin 17

scuffing & red deposits after fuel transition: causes and solutions

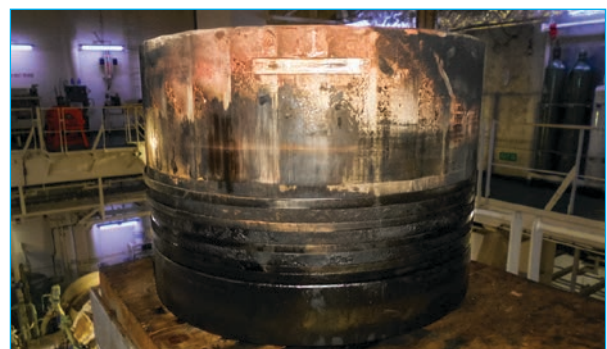
A number of vessels that have switched to VLSFOs reported abnormal main engine liner wear, identified through routine DOT.FAST® onboard testing. In these cases, evidence of liner scuffing and red deposits formed locally on piston crowns or top edges was recorded, with red colored iron burrs in the scavenge port discovered in a few instances.

A) Piston with scuffing and deposits.

In most cases the scuffing appeared only on individual liners. Some scuffed units showed red deposits on piston crowns with other units showing no signs of either scuffing or deposits.

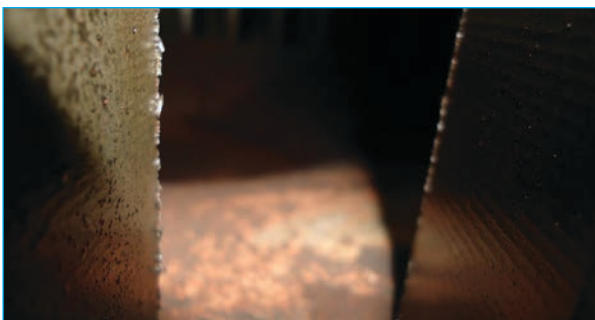
B) Iron burrs in scavenge port.

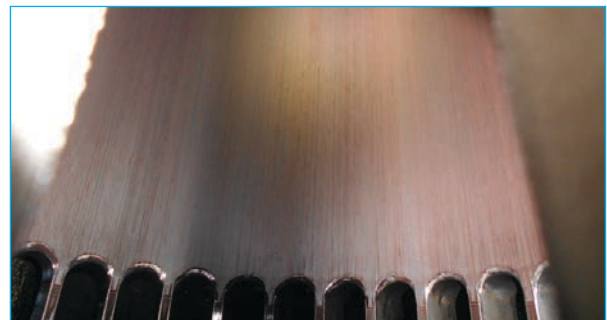
C) Cylinder liner with deep red layer with scoring marks.

The issue of red deposits did not impact all of the cylinders, but it was found in some cylinders with pre-existing poor cylinder liner or piston ring pack condition.

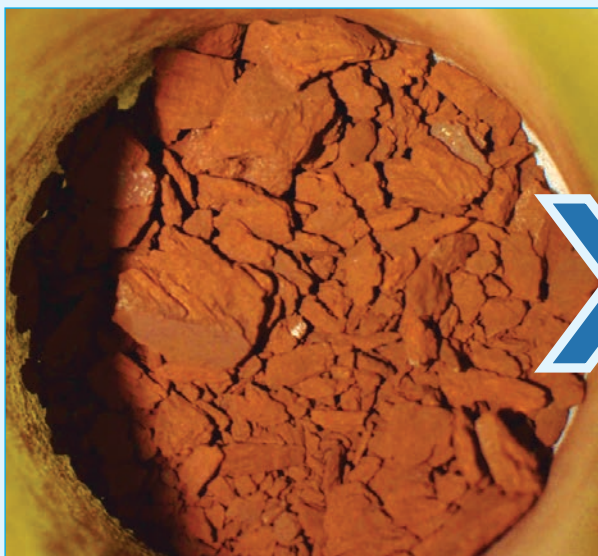
Figure 2: An example of the red deposits analysed at Chevron laboratories

Following this program of analysis, the results indicate that the deposits contain very little organic material. This suggests that the source of the calcium sulphate — not a cause for concern in itself — is probably as a result of harmless detergent additives from the lubricants. The iron oxide, however, is the result of harmful abrasive wear of the piston and liner.

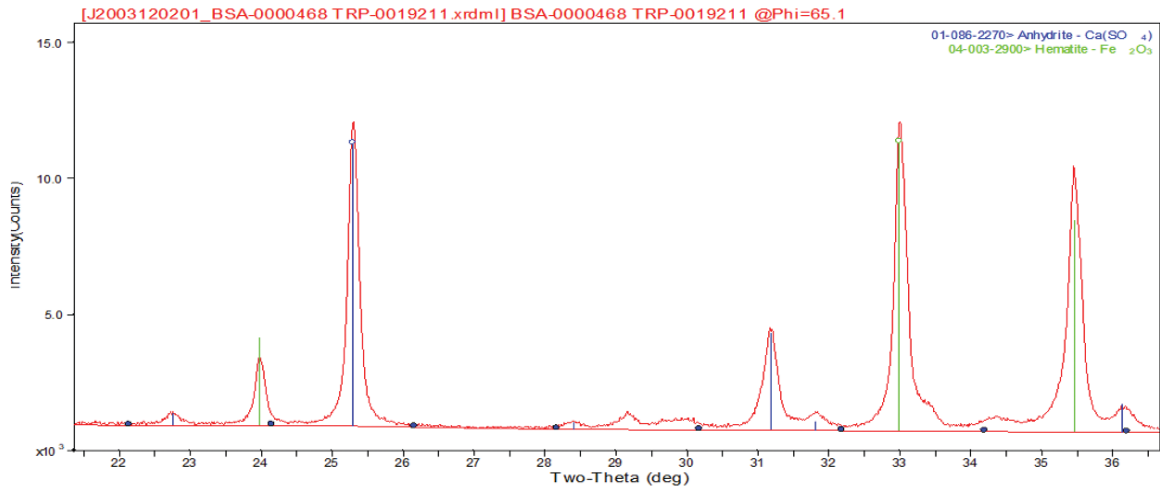
Figure 4: X-Ray Diffraction Analysis

Conclusion: The XRD analysis indicates that the red deposit consists of mostly crystalline materials as Anhydrite CaSO_4 and Fe_2O_3 (Hematite). Hematite is even harder than ferrous metal.

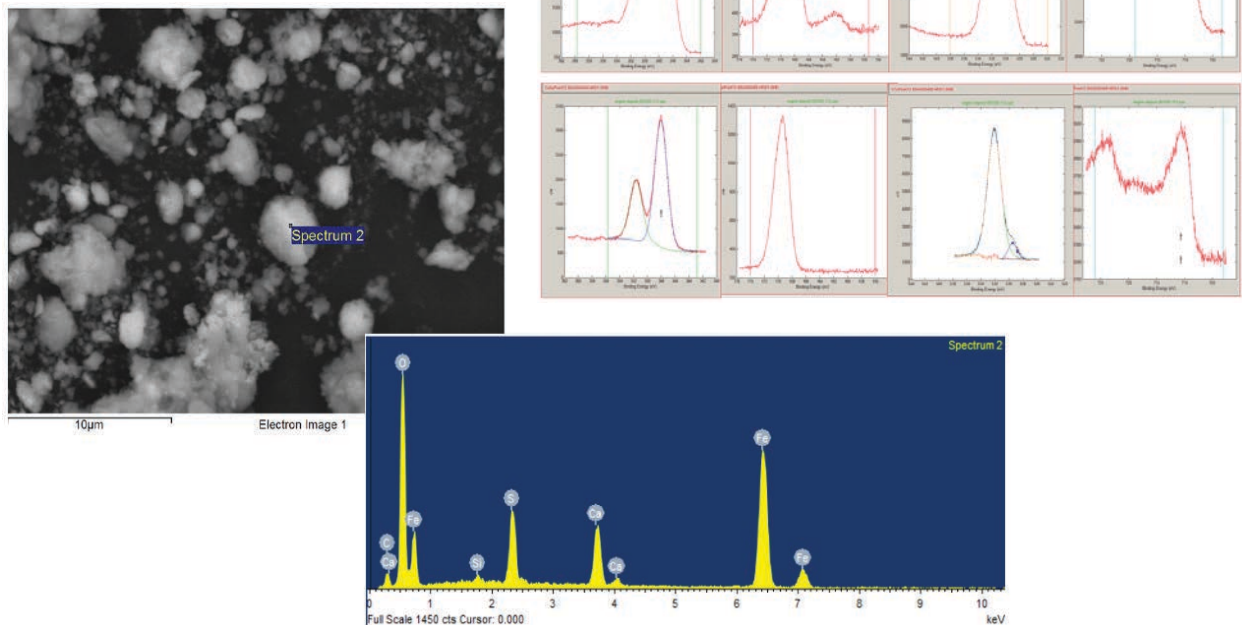
Figure 5: SEM/EDX + XPS Visual screening and point at specific particles to determine the elemental composition of the particles

- The major phase(s) in this sample (>95%) consists of Ca, S, Fe and O which are calcium sulfate and iron oxide.
- Trace amounts (<5%) of Ni, Cu, P, Si were also detected.
- Interestingly, the morphology of some of the iron particles are in the form of spheres (~10µm in size). While the most obvious inference is that the iron oxide is rust, please note that welding spatter also tends to form such spheres.
- The morphology of other types of particles are random and they too contain iron.
- The iron oxide spheres seem to have been bound by the calcium sulfate material.

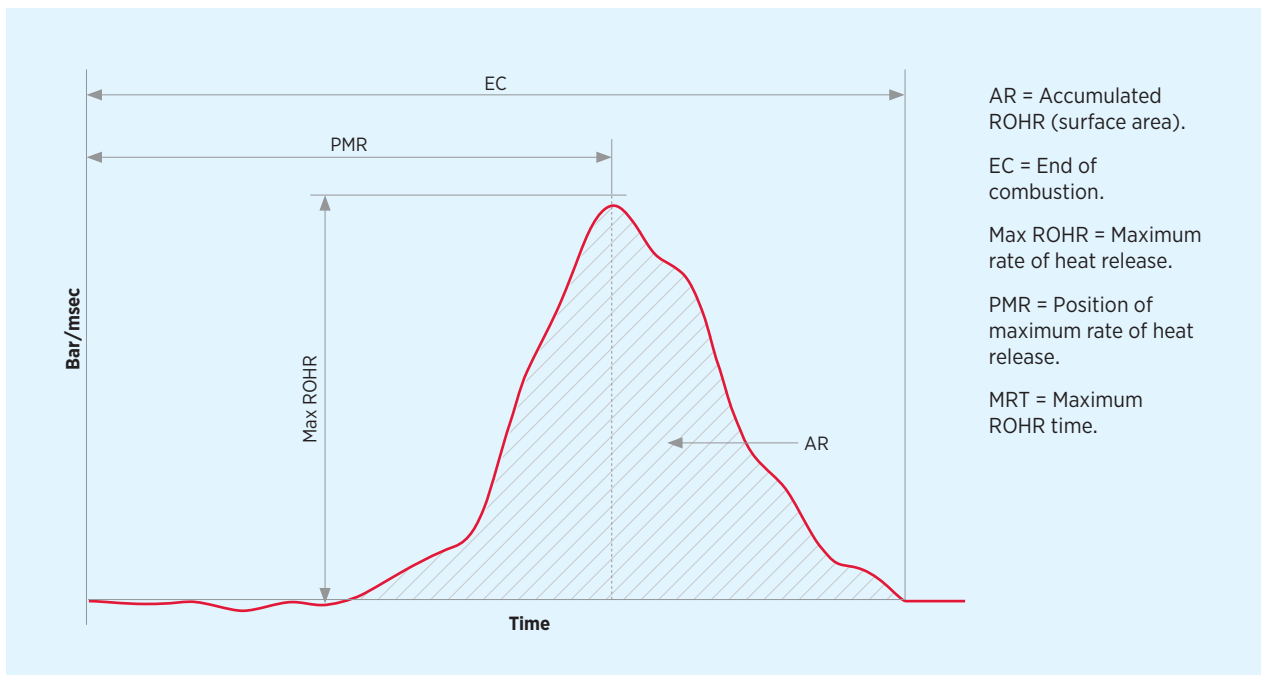
Figure 6A: ROHR = Rate of Heat Release

- VLSFOs analysed showed excellent combustion properties — typically faster burning, higher energy release than traditional HSFO.
- The time between injection and reaching maximum pressure is shorter, hence peak combustion is reached earlier in the combustion cycle.
- Overall, more energy released — typically higher max ROHR level.

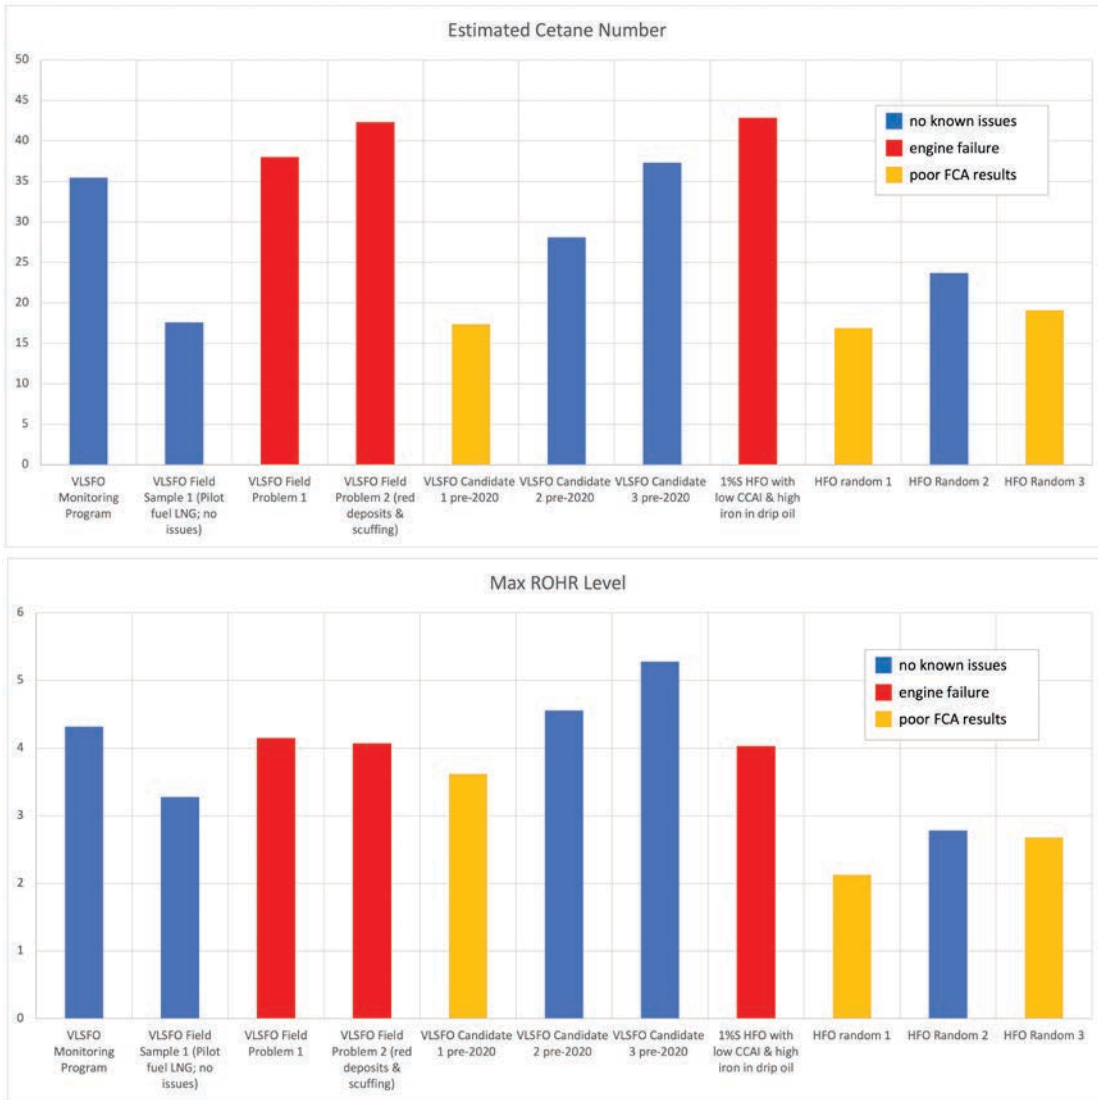
Figure 6B: Comparison of ROHR from different batches of VLSFO

VLSFO from liner scuffing cases showed typically low CCAI and high ECN. The key observation is that most VLSFOs typically have a lower CCAI in comparison with compared to HSFOs.
